Risk Factors for Growing Rod Fractures

Justin Yang, **Paul Sponseller**, George Thompson, John Emans, Muraheem Yazici, Lawrence Karlin, Marc Asher, Suken Shah, David Skaggs, Peter Newton, Richard McCarthy, Rishi Kadakia, Connie Poe-Kochert, Ashley Goldthwait, Behrooz Akabarnia

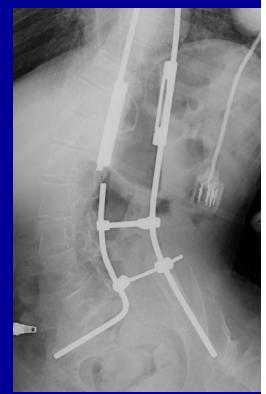
Results: Material and Size

- Stainless steel rods had a higher fracture rate than titanium rods (trend)
 - 19% vs. 12%, P=0.06
 - Controlled for rod diameter, single vs dual

- The mean rod diameter was smaller in the fracture group
 - 4.1 mm vs. 4.8 mm, P=0.01
 - Controlling for rod material and number of rods

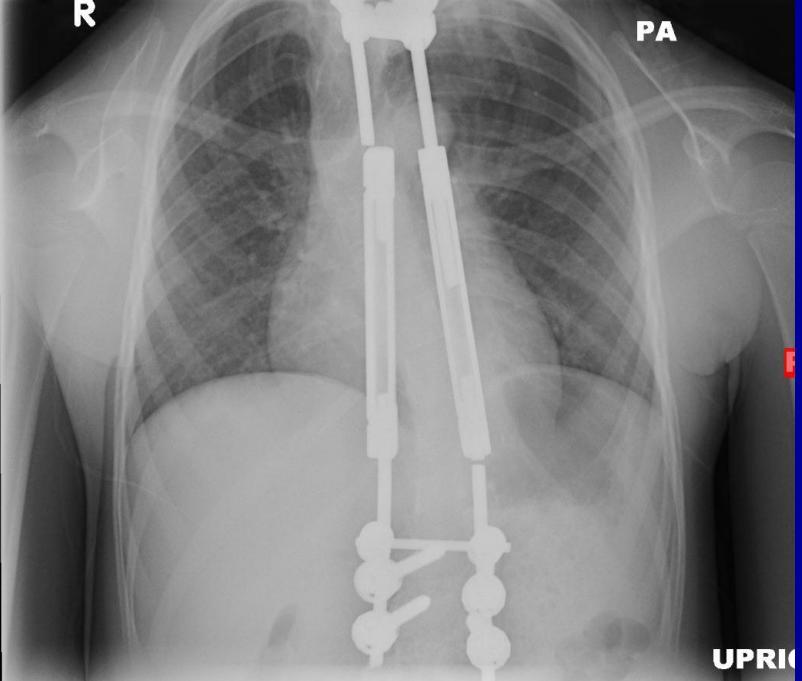
Results: Location

Most common fracture locations were at tandem connectors (30/71)
 No difference above (17/30) or below (13/30)
 Within 10 mm

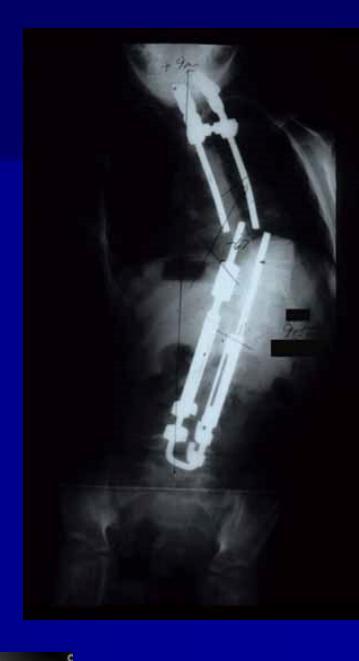
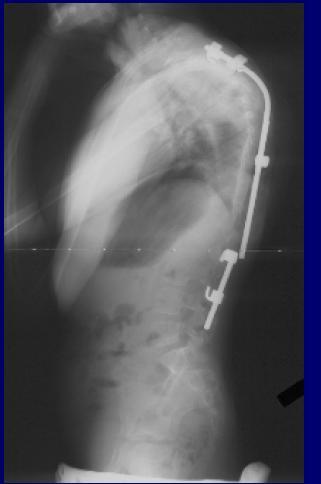
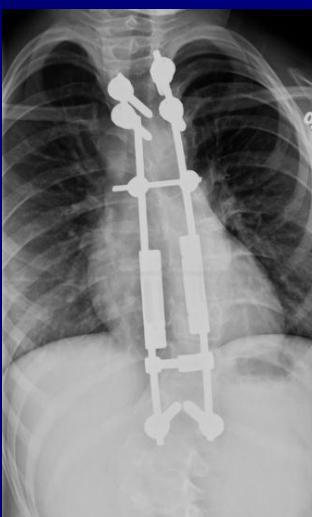
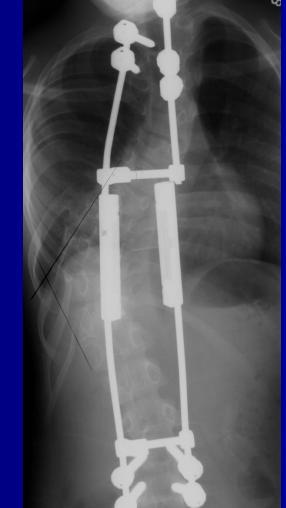
Results: Location

Other locations included:
 Mid-rod (31/71)
 At hooks (7/71)
 At screws (2/71)
 At crosslinks (2/71)

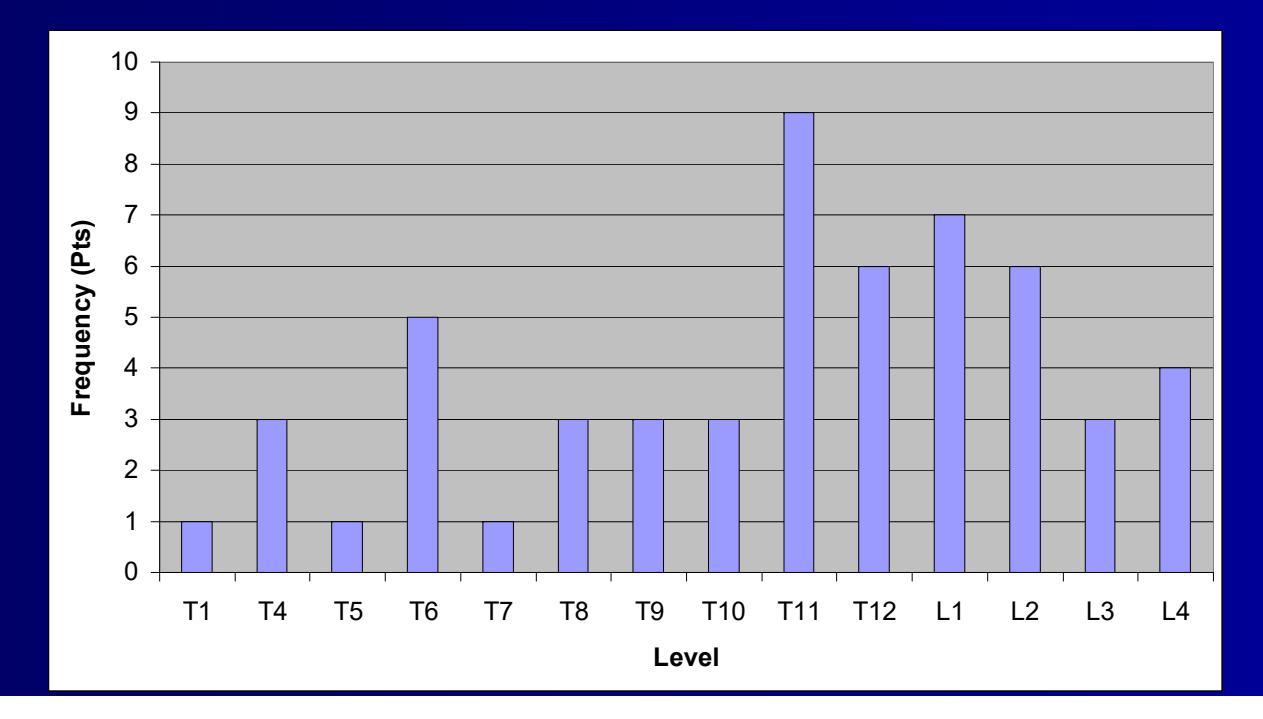
Levels of fracture

Thoracic (T2-10): 20
Thoracolumbar (T11-L1): 21
Lumbar (below L1): 13

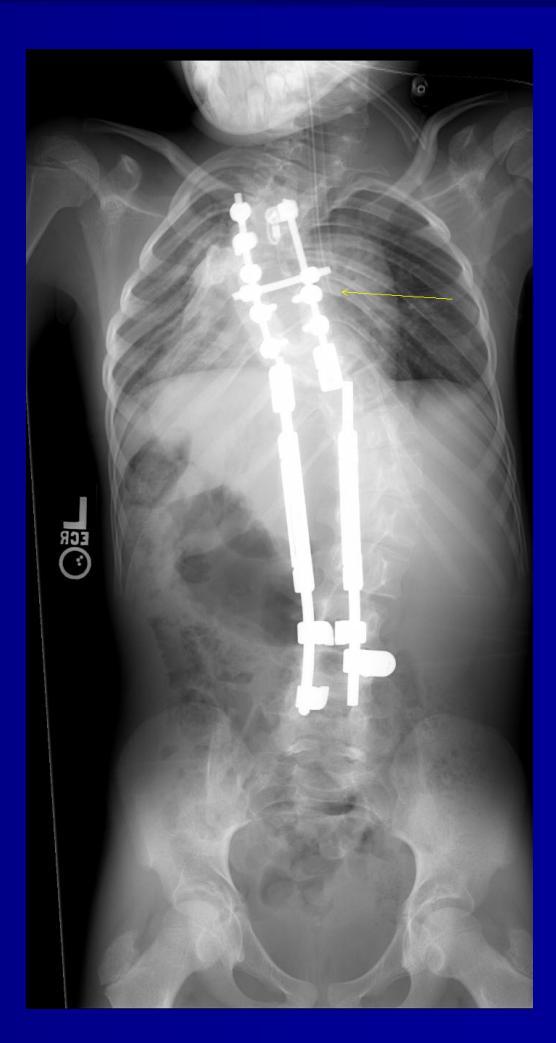
Convexity/Concavity

For dual growing rods with single major curve:

- Rod fractures on convex side: 10
- Rod fractures on concave side: 6

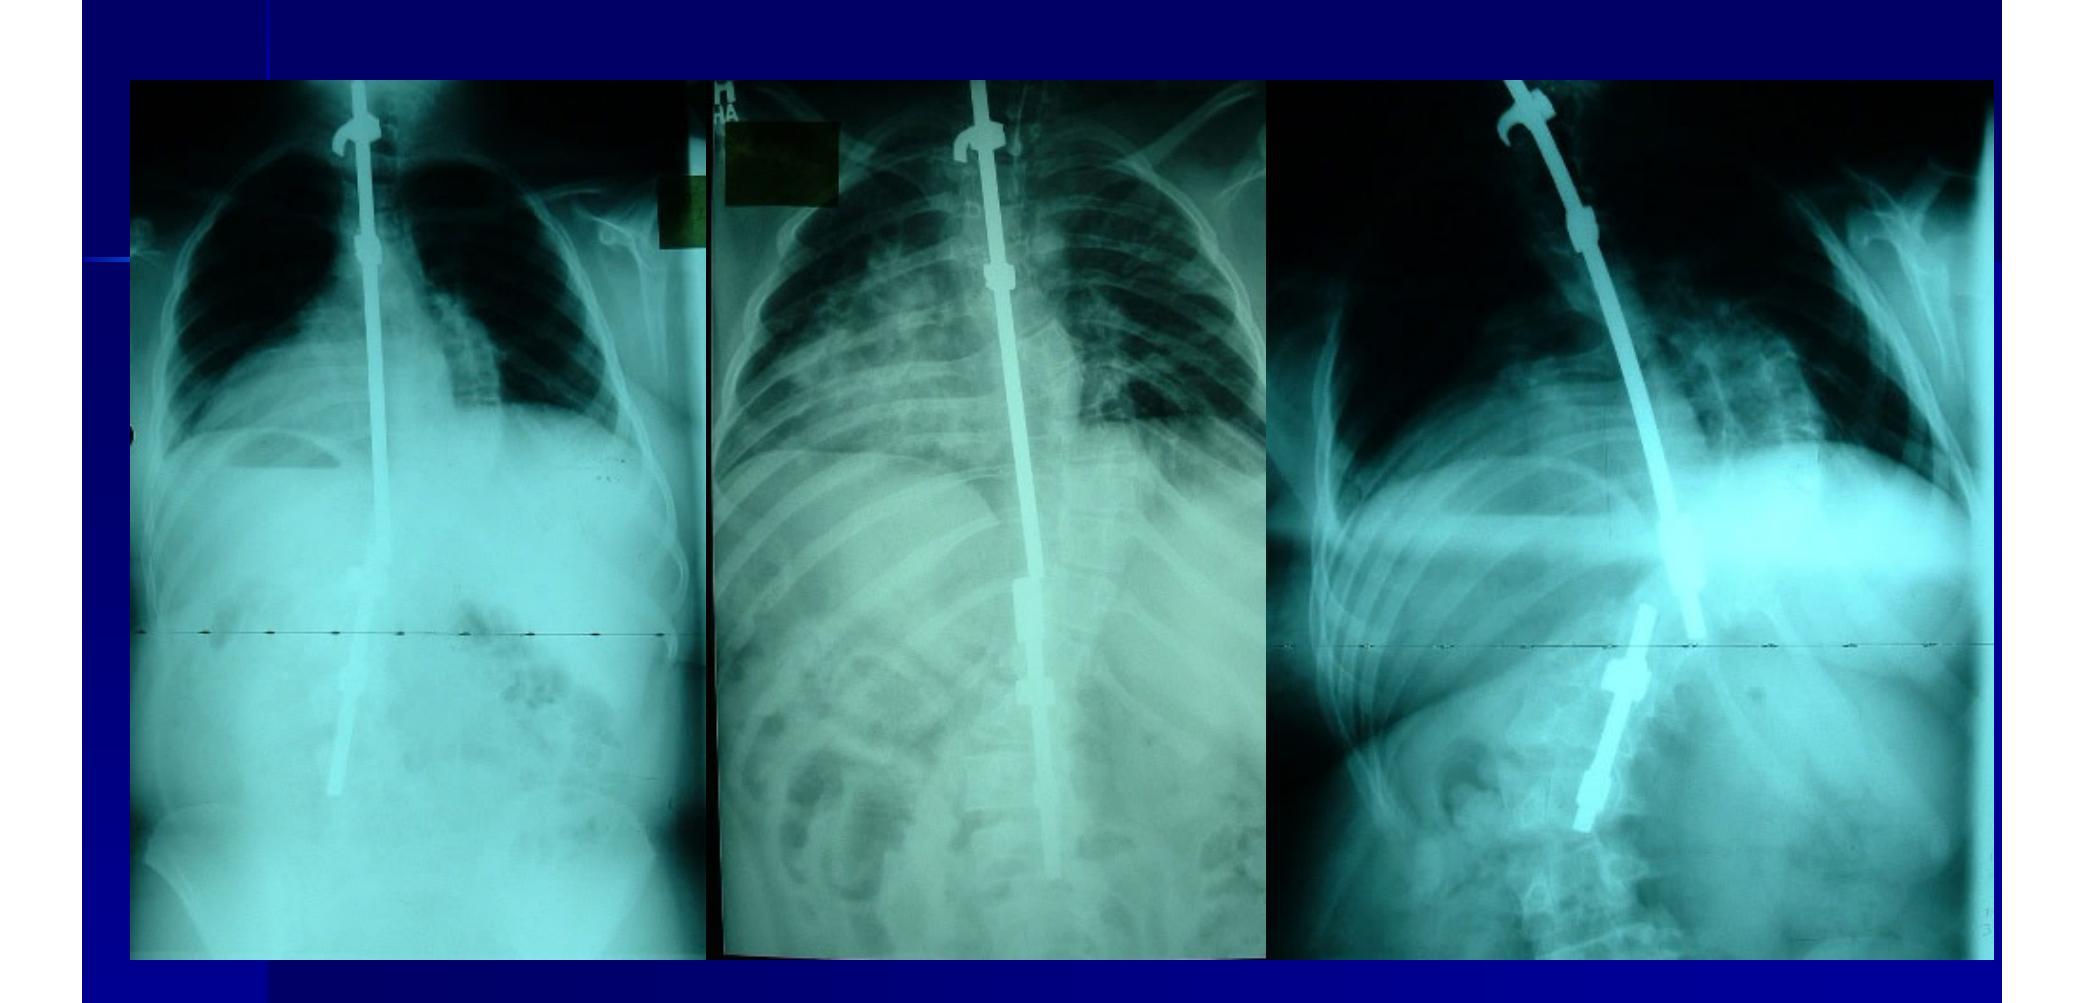
Results: Repeat fractures

Repeat fractures occurred in 30% (13/44) patients

-3 fx (2), 4 fx (1), 6 fx (1)

- Primarily with single rods (77%, 10/13)
- Significantly less in dual rod constructs (23%, 3/13), P=0.02
 - Pt with dual rod fx still increased risk
 - For dual rod constructs, all repeat fractures occurred on the ipsilateral side

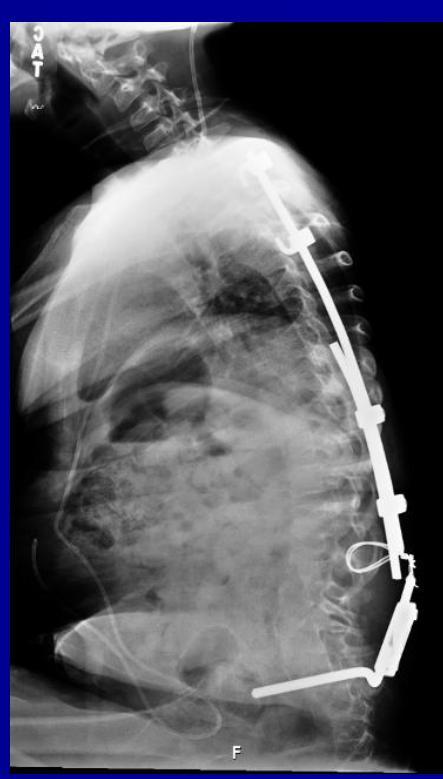
Results: Complications/Treatment

- Eight wound complications were reported
 - 3 through skin

Rod fractures salvaged by:
 Adding tandem connectors (20)
 Replacing the broken rods (44)
 Final Fusion (2)
